## 冻融循环前后古建筑青砖的冲击损伤研究

## Study on Impact Damage of Ancient Building Grey Bricks Before and After Freeze–thaw Cycles

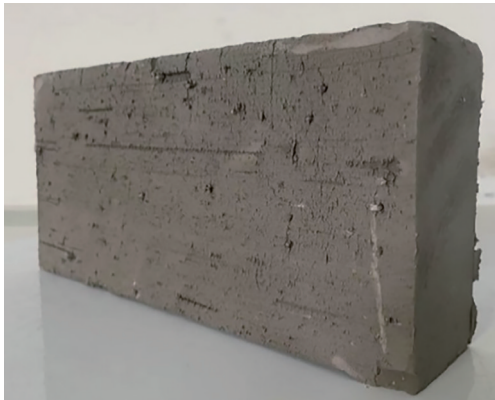
图 1 青砖试件

隆盛庄位于内蒙古自治区乌兰察布市丰镇镇东北部,2014年被列为第六批中国历史文化名镇。由于隆盛庄青砖墙体在自然环境中经历百年侵蚀,青砖的物理、力学性能发生了不同程度的退化,加之现存的古青砖具有极高的历史文化价值,故依据《文物建筑维修基本材料 青砖》(WW/T0049—2014)中古建筑修复的选材原则,采用内蒙古呼和浩特鸿宇古建出售的仿古青砖,该青砖以黏土为原材料,采用传统生产工艺烧制而成,如图 1 所示。对比隆盛庄古青砖和仿古青砖的矿物成分(图 2)和基本性能(表 1)可知,二者具有相似性,故可采用该仿古青砖代替古青砖进行研究。

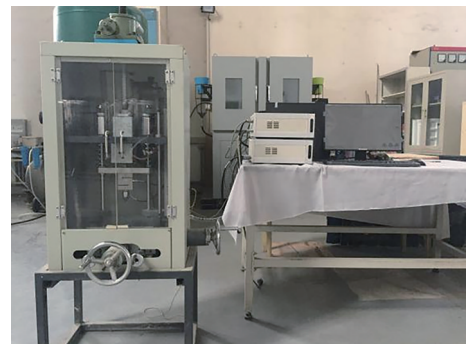
图 3 自动冲击球压仪

冲击试验采用自主研发的自动冲击球压仪,通过球头上力学传感器对冲击过程中的冲击力进行实时采集并输出到相匹配的测试软件,自动冲击球压仪如图 3 所示。试件冲击高度选择 23.0、25.0、27.0、29.0、31.0、33.0、35.0、37.0、39.0 cm 共 9 个冲击高度,每个试件设置 6 个冲击点,且测试点与试样边缘距离大于 2.5 cm,各测点间距大于 3.0 cm,冲击球头选用半径为 5 mm 的碳化钨小球,其弹性模量和泊松比分别为 600 GPa、0.15。同时,利用 3D-DIC 非接触式全场形变测试系统测试青砖在冲击荷载作用下的位移场和应变场,该系统由两个 CCD 相机、两个光源以及 VIC-3D 图像分析系统组成。冲击试验后通过 VHX-7000 型超景深三维显微镜和扫描电子显微镜量测青砖表面损伤形貌。

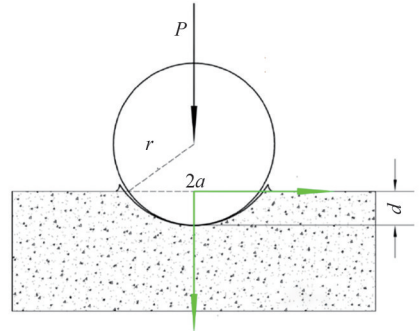
图5 冲击球压模型

理论<sup>[32]</sup>将弹性压缩阶段看成刚性球体与弹性半空间体的接触问题。假设一个质量为  $m$ 、半径为  $r$ 、弹性模量为  $E_1$ 、泊松比为  $V_1$  的刚性小球垂直冲击一个弹性模量为  $E$ 、泊松比为  $V$  的弹塑性半空间体材料表面,冲击过程中产生的冲击荷载为  $P$ ,形成的压痕深度和压痕直径分别为  $d$  和  $2a$ 。冲击球压模型如图5所示。

由图5可知,接触压力分布为:

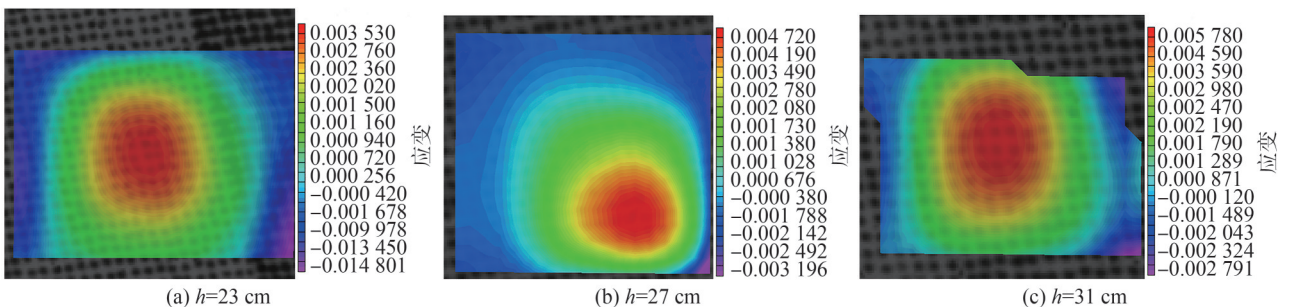
图8 不同冲击高度下青砖压痕区域径向应变云图

图8不同冲击高度下青砖压痕区域径向应变云图,展示在不同冲击高度(23、27、31、35、39 cm)下青砖压痕区域径向应变的变化分布, $h$ 为冲击高度。

由图8可知,在冲击荷载作用下,青砖压痕的径向应变以冲击中心为原点向四周呈环状扩展分布,且损伤区域的应变随距冲击中心距离的增大而减小。为了更好地描述压痕区域径向应变的分布情况,

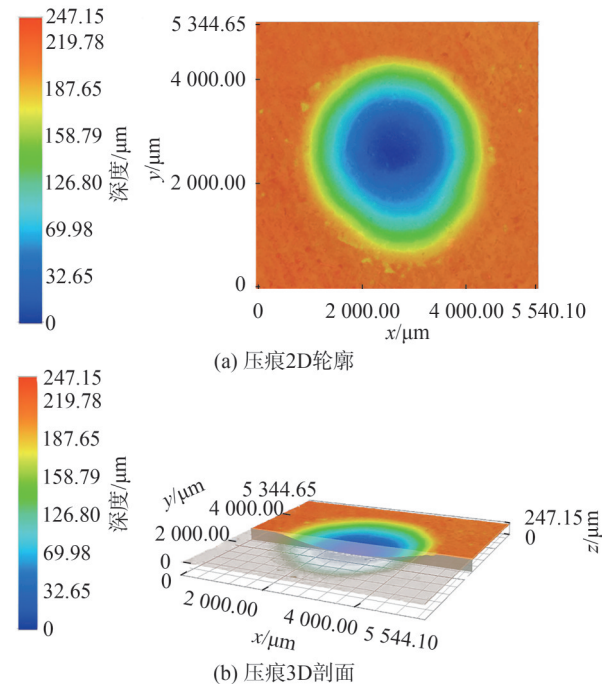
图 17 青砖二维、三维压痕形貌图

利用 VHX6000 型超景深三维显微镜对青砖表面的压痕进行量化采集,通过 VHX6000 型超景深三维显微镜对压痕形貌的二维、三维形貌进行分析以及对压痕几何参数进行量测。图 17 分别为青砖在 31 cm 冲击高度下的 2D 轮廓、3D 剖面图。图 17(a) 图片尺寸为  $5\,344.65\ \mu\text{m} \times 5\,544.10\ \mu\text{m}$ 。由图 17 可知,青砖在冲击荷载作用下会形成球冠状小坑,且相同半径的轴向同心圆其压痕离面位移沿径向呈环形分布。图 17(b) 为压痕 3D 剖面,通过对压痕 3D 轮廓进行剖切可精确得到压痕的深度、直径、表面积以及体积分别为  $247.15\ \mu\text{m}$ 、 $3\,912.74\ \mu\text{m}$ 、 $11.13\ \text{mm}^2$  及  $1.21\ \text{mm}^3$ 。

由图17可知,在冲击荷载作用下,青砖表面出现明显的塑性变形特征,冲击区域会产生球冠状压痕,且压痕直径随冻融循环次数的增加呈递增的趋势。未冻融的青砖在冲击荷载作用下形成的损伤区域较完整,损伤区形状为圆球形凹痕;当冻融循环10次时,青砖受冲击后其表面的压痕区域变得粗糙,这是冻融循环作用使得青砖内部矿物成分与胶结材料的连接性降低,进而导致压痕周围在冲击拉压力作用下挤出较多的颗粒物,压痕边缘出现剥落现象(图18(b));冻融循环30次以后,压痕边缘出现剥落现象,且青砖损伤区压痕尺寸明显增大(图18(c)~(d))。这是由于材料表面和内部结构的不同,在相同冲击荷载作用下损伤的情况也不相同,对于未冻融时青砖内部结构密实无明显缺陷,在冲击荷载作用下,青砖表面抗塑性变形能力较强,产生的塑性变形最小,因此形成的冲击坑较浅;冻融循环会导致青砖内部孔隙和微裂缝数量增多,在冲击荷载作用下,裂缝扩展的路径增多,冲击能量更多地转化为试样表面损伤的能量,因此在冲击坑内部会出现颗粒脱落现象,且压痕深度和半径增大。
